FLIGHT MEASUREMENTS OF THE FLYING QUALITIES

OF AN F6F-3 AIRPLANE (BUAER NO. 04776)

II - LATERAL AND DIRECTIONAL STABILITY AND CONTROL

By Walter C. Williams and John P. Reeder

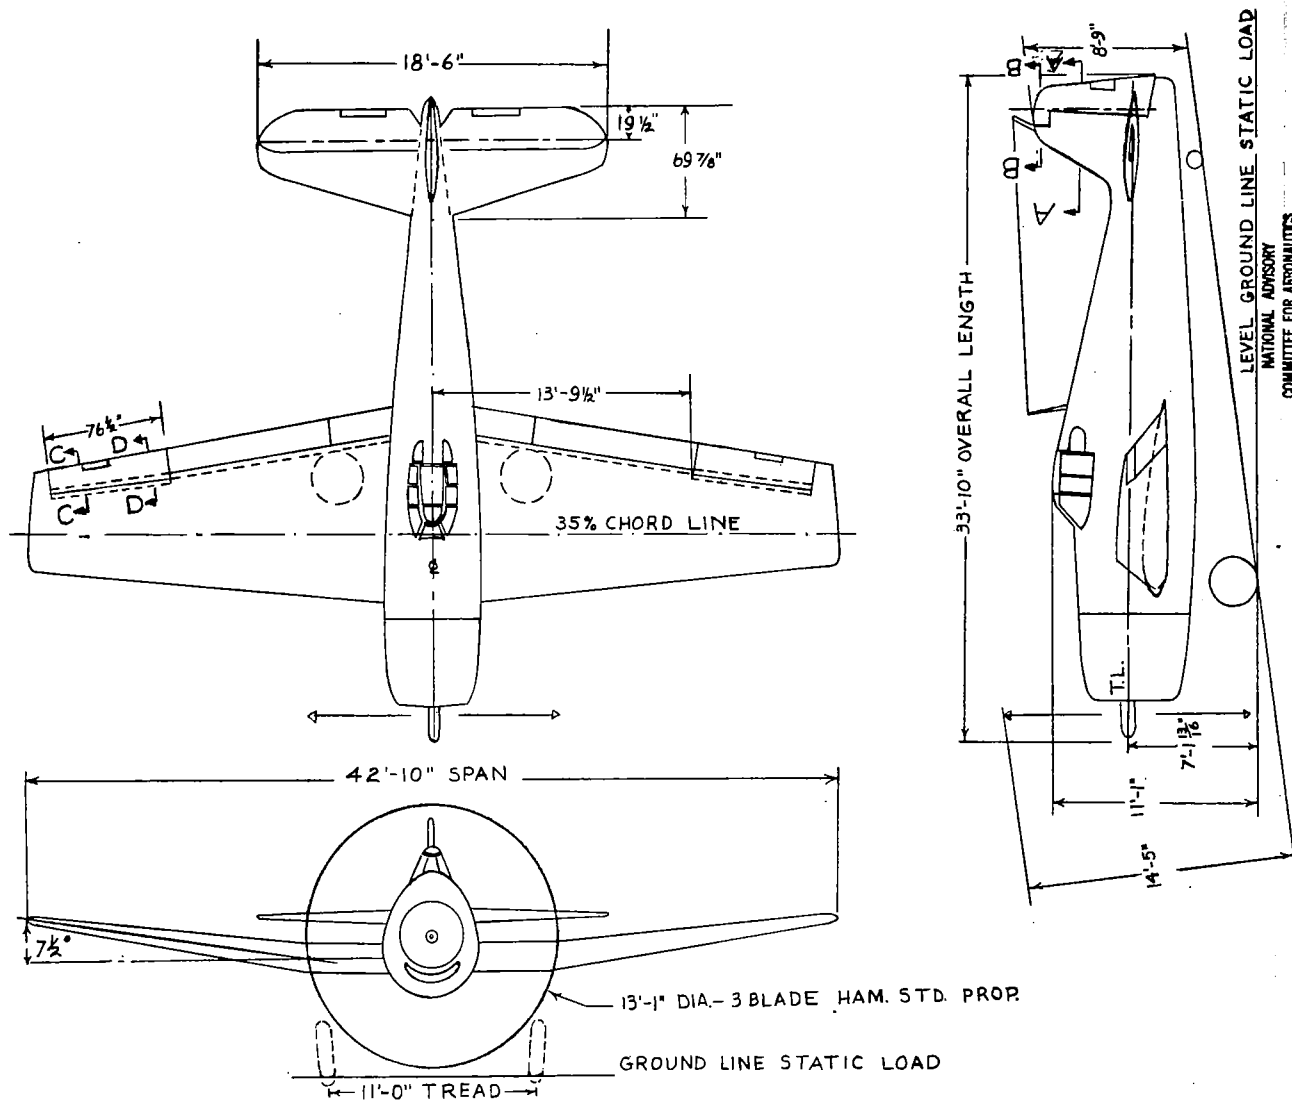
Figure 1. - Three-view layout of the F6F-3 airplane.

A three-view layout of the F6F-3 airplane is shown in figure 1. Pertinent details and dimensions of the F6F-3 airplane are given in reference 1. The relation between control-surface deflection and stick and rudder pedal position is shown in figure 2 for the rudder and aileron controls. Rudder angles are measured in degrees from the fin and aileron angles are referenced to neutral. Trim-tab angles are given in degrees from the control surface. Sections of the rudder are given in figure 3. Figure 4 gives aileron sections. Section letters on figures 3 and 4 correspond to the sections shown on figure 1. The products of the span and chord squared, on

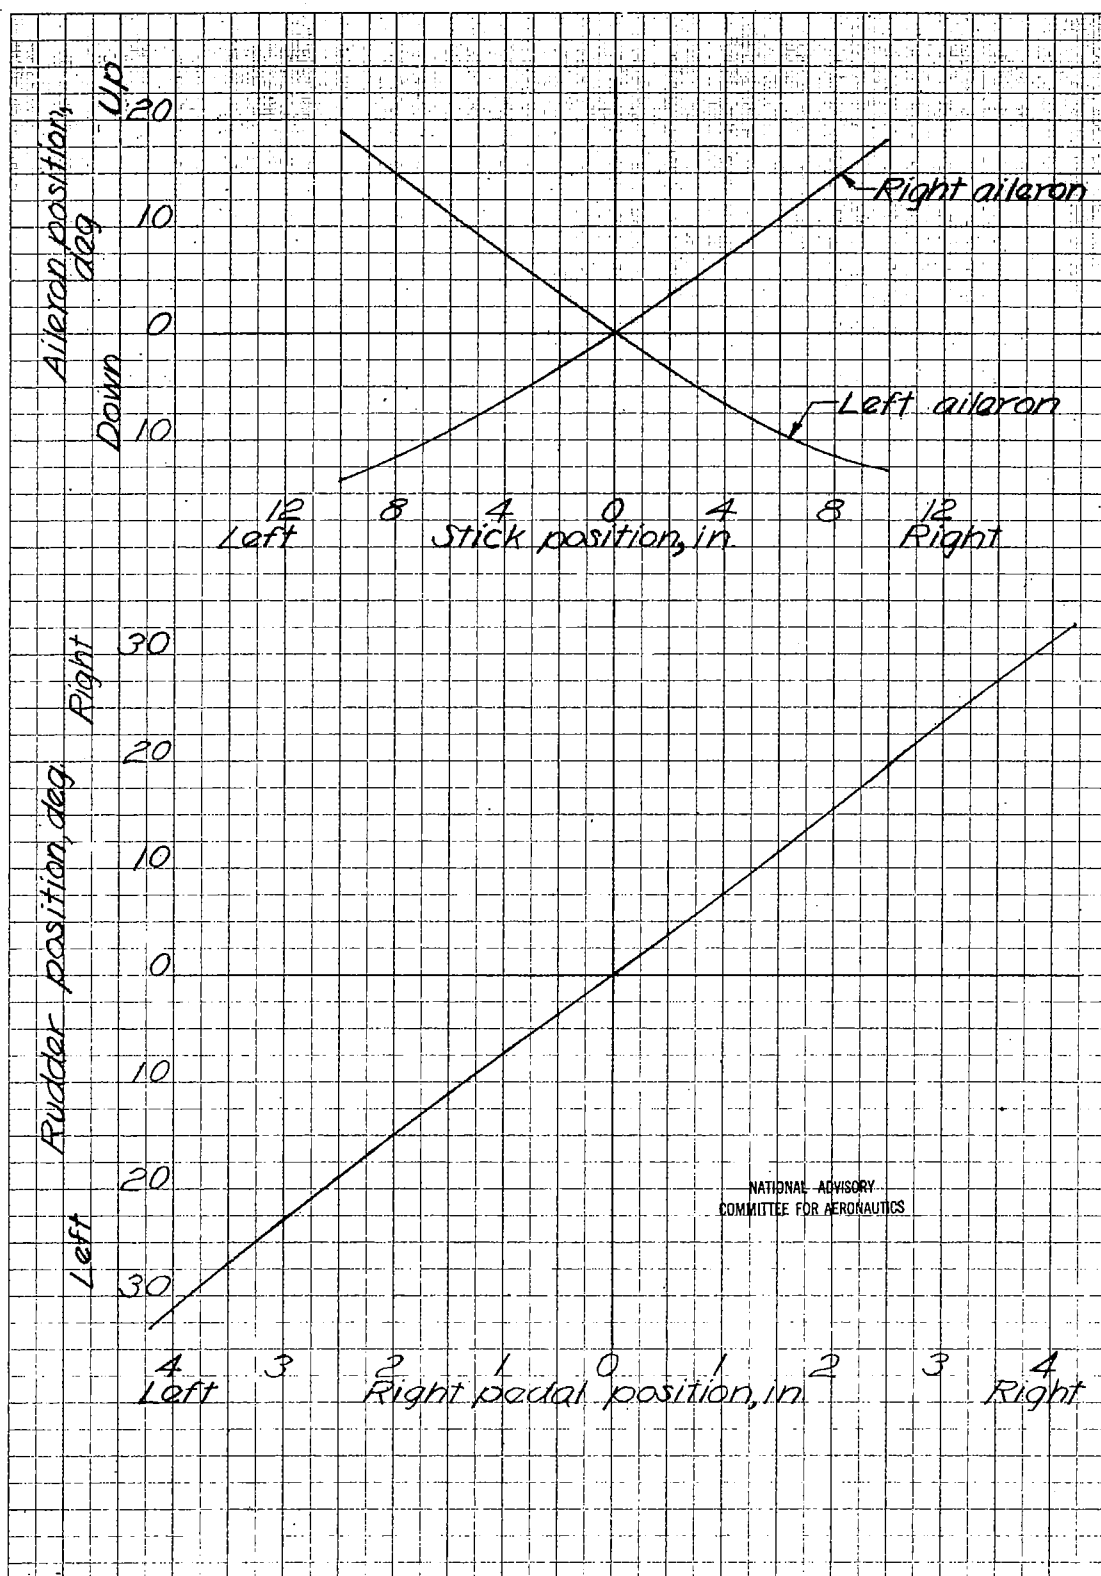
Figure 2. - Variation of control-surface deflection with stick and rudder pedal position. F6F-3 airplane.

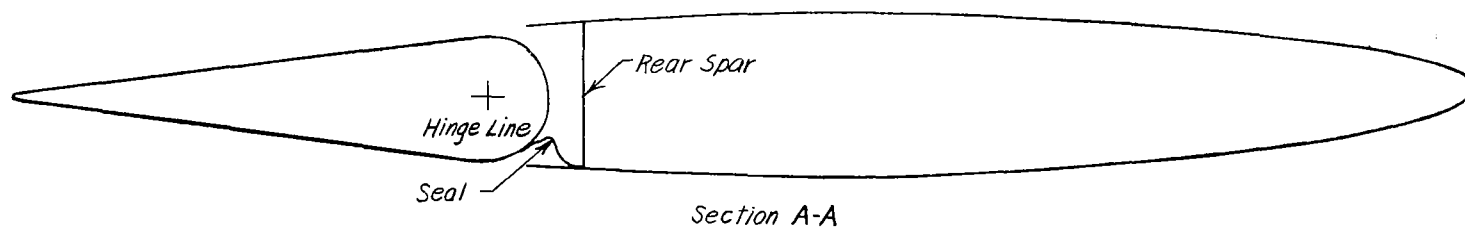
Figure 3. - Section of vertical tail, F6F-3 airplane.

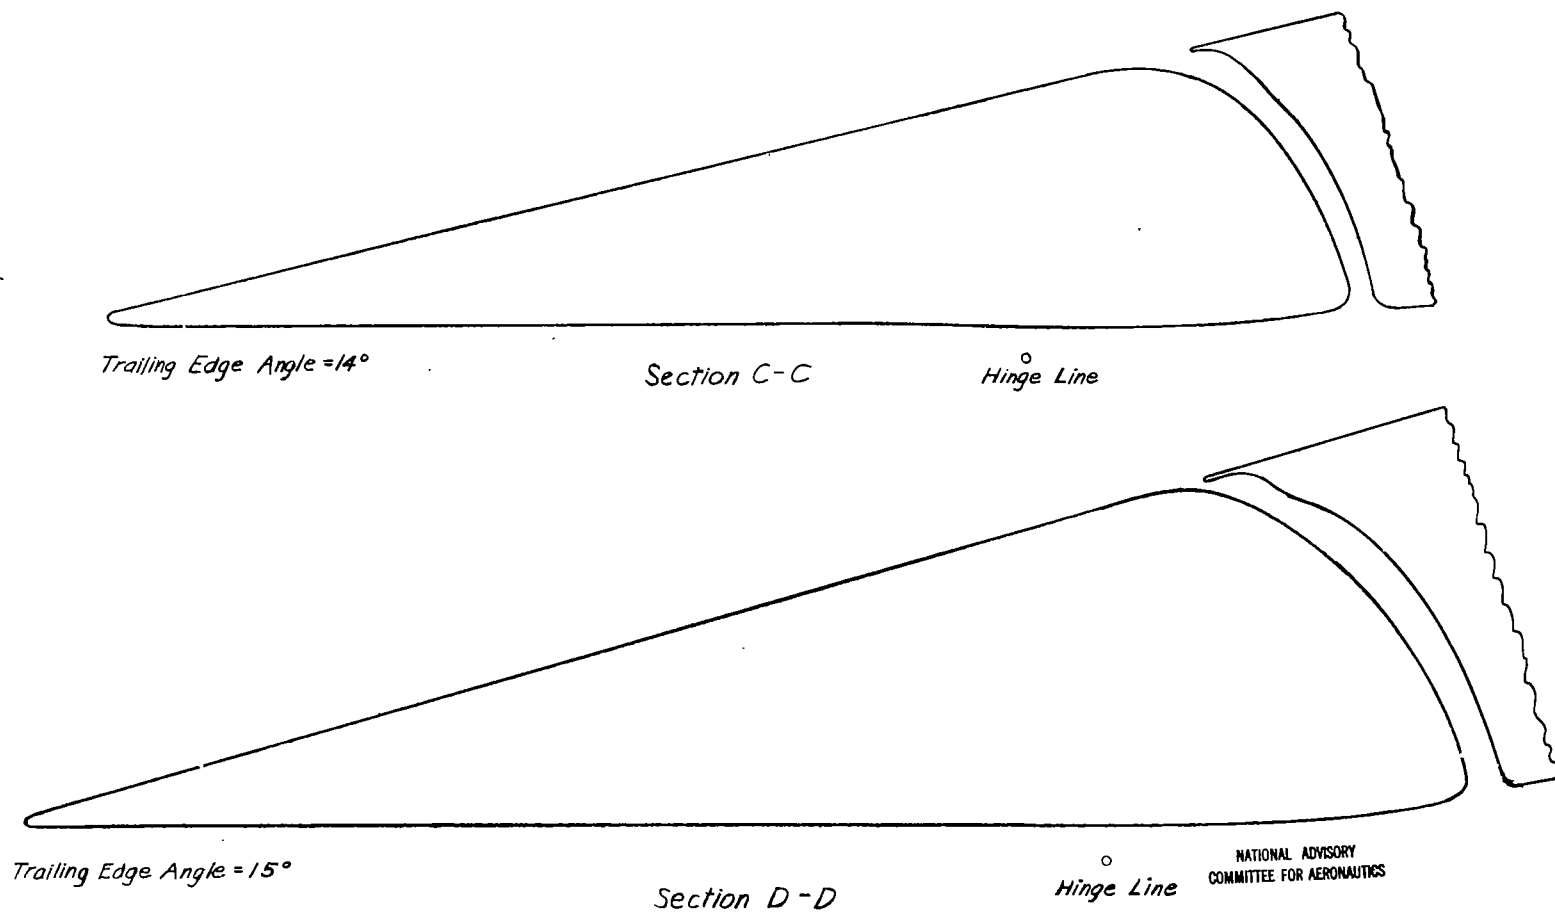
Figure 4. - Section of right aileron, F6F-3 airplane.

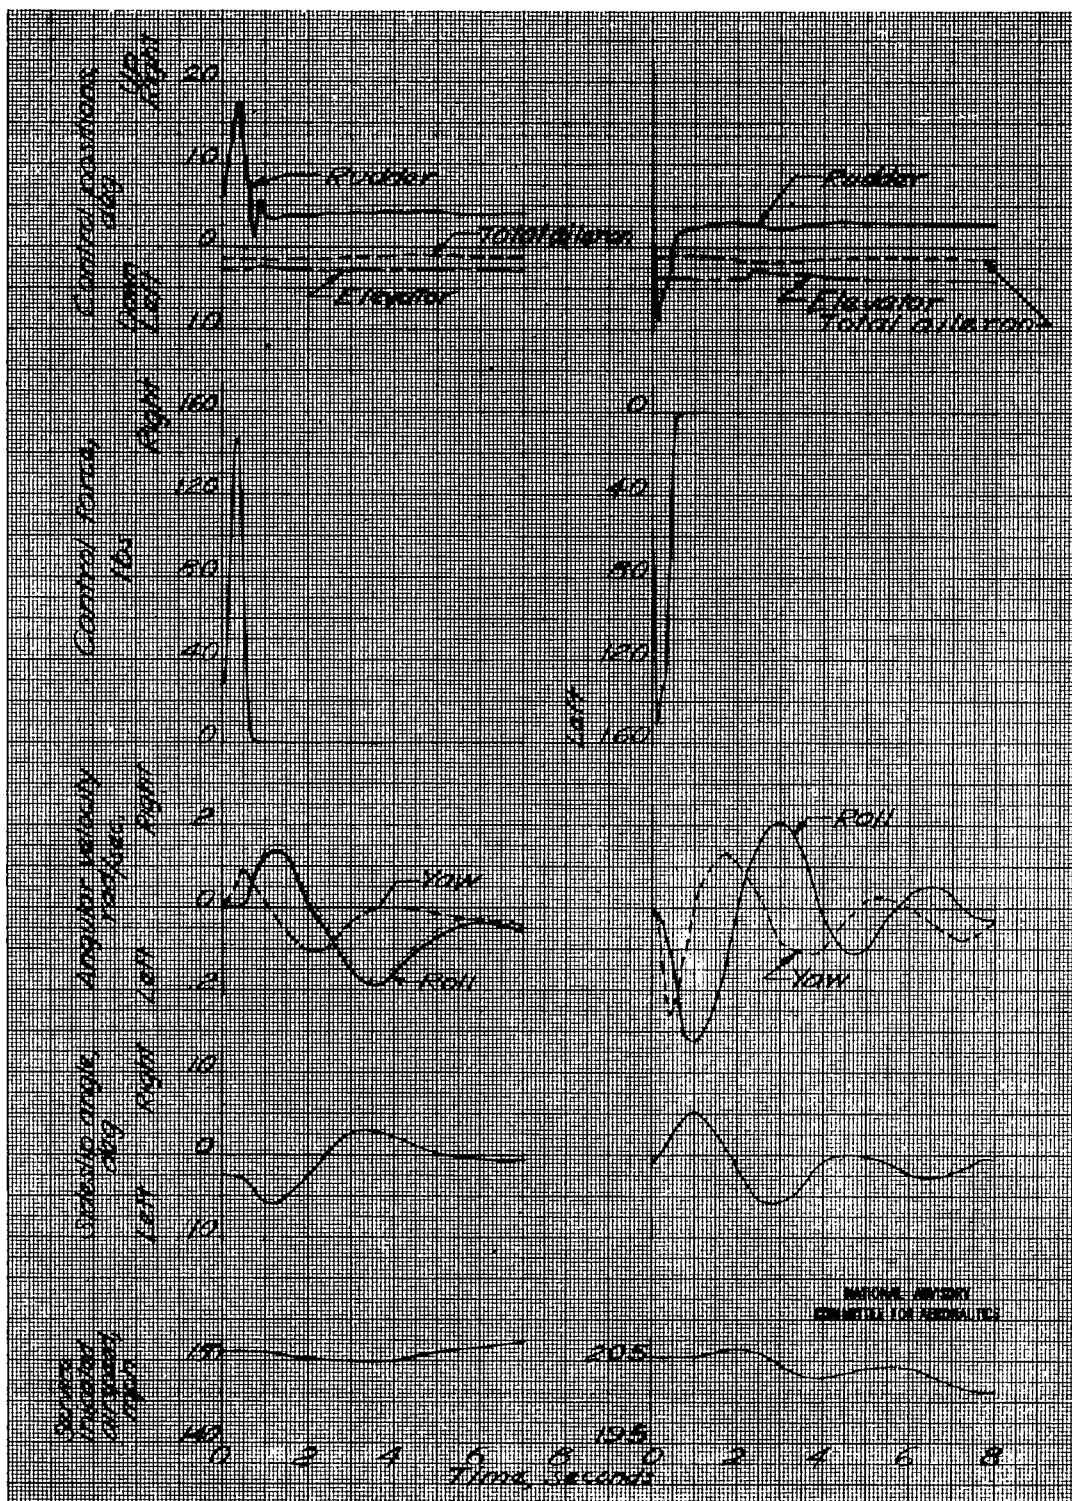
Figure 5. - Time histories of typical lateral oscillations following abrupt rudder deflection, climbing condition, F6F-3 airplane.

The characteristics of the uncontrolled lateral and directional motion were determined in the speed range from 100 to 300 miles per hour for the gliding condition and climbing condition. In these tests the airplane was trimmed for laterally level flight and continuous records were taken while the pilot abruptly deflected the rudder, then released all controls. Typical time histories of this maneuver are shown in figures 5 and 6. The variation of the period of the lateral oscillation with service indicated airspeed is shown in figure 7. It can be seen, on figures 5 and 6, that the short-period lateral oscillations damped to half amplitude within two cycles, satisfying the requirements. Figure 6, however, shows that a lateral oscillation of small amplitude continued and was poorly damped. This oscillation was noticed by the pilots and was considered objectionable.

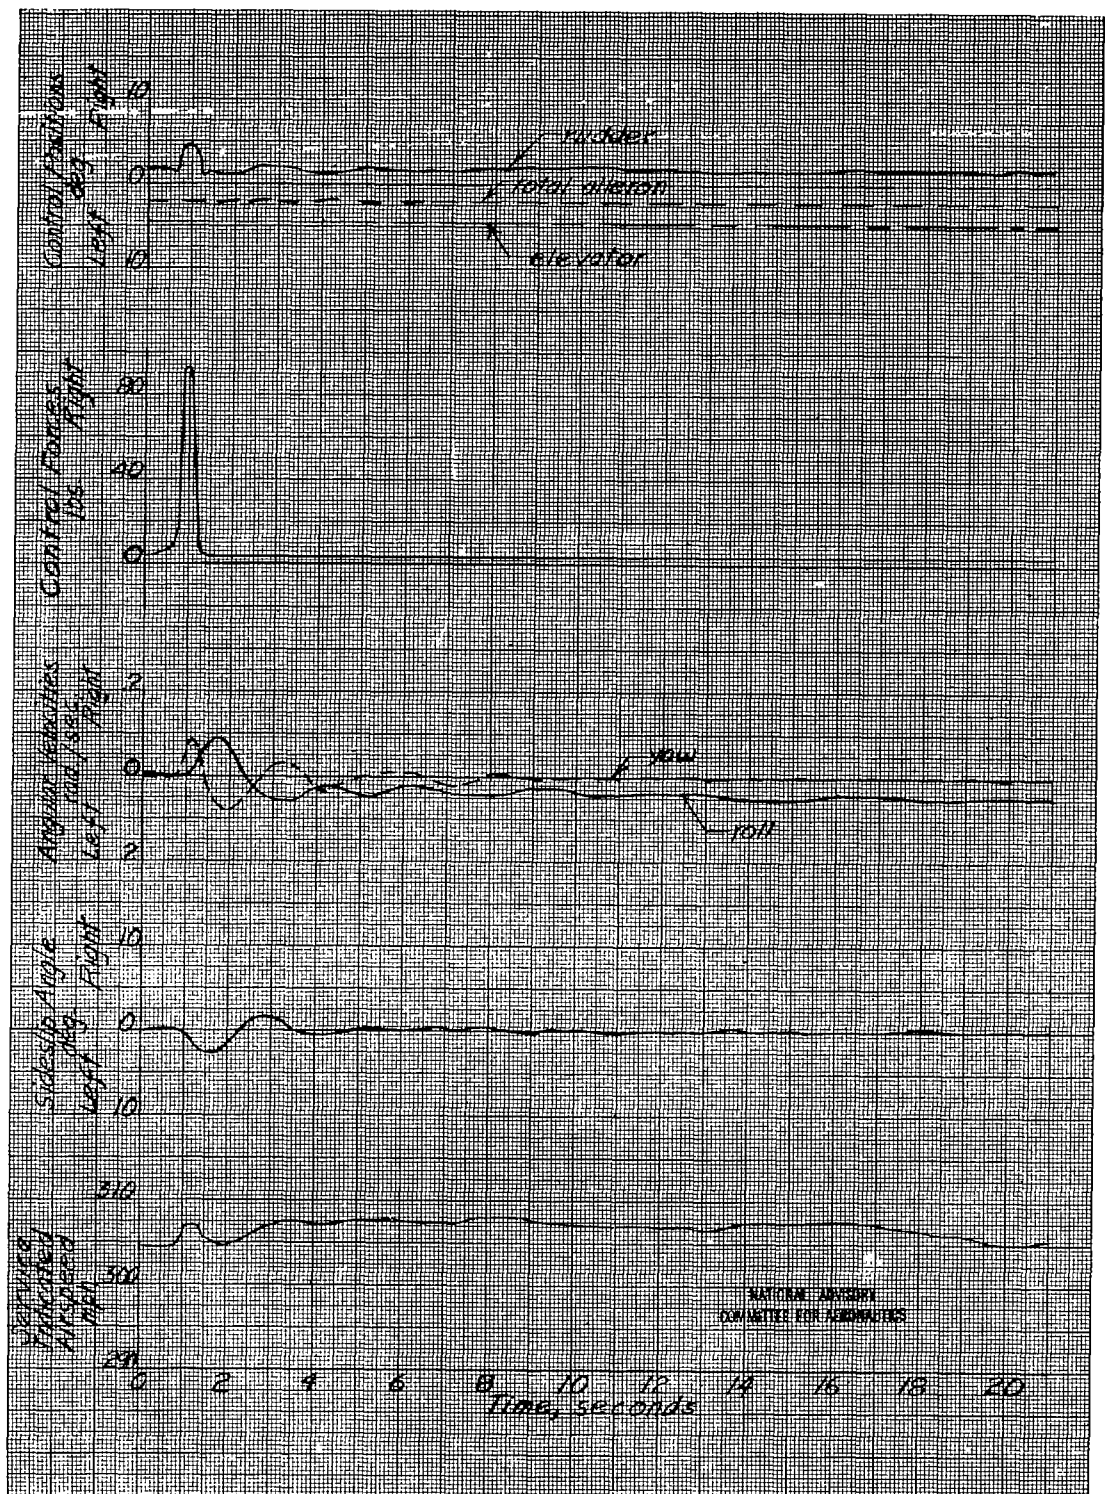
Figure 6. Time history of a typical lateral oscillation following an abrupt rudder deflection at approximately 305 miles per hour, climbing condition, F6F-3 airplane.

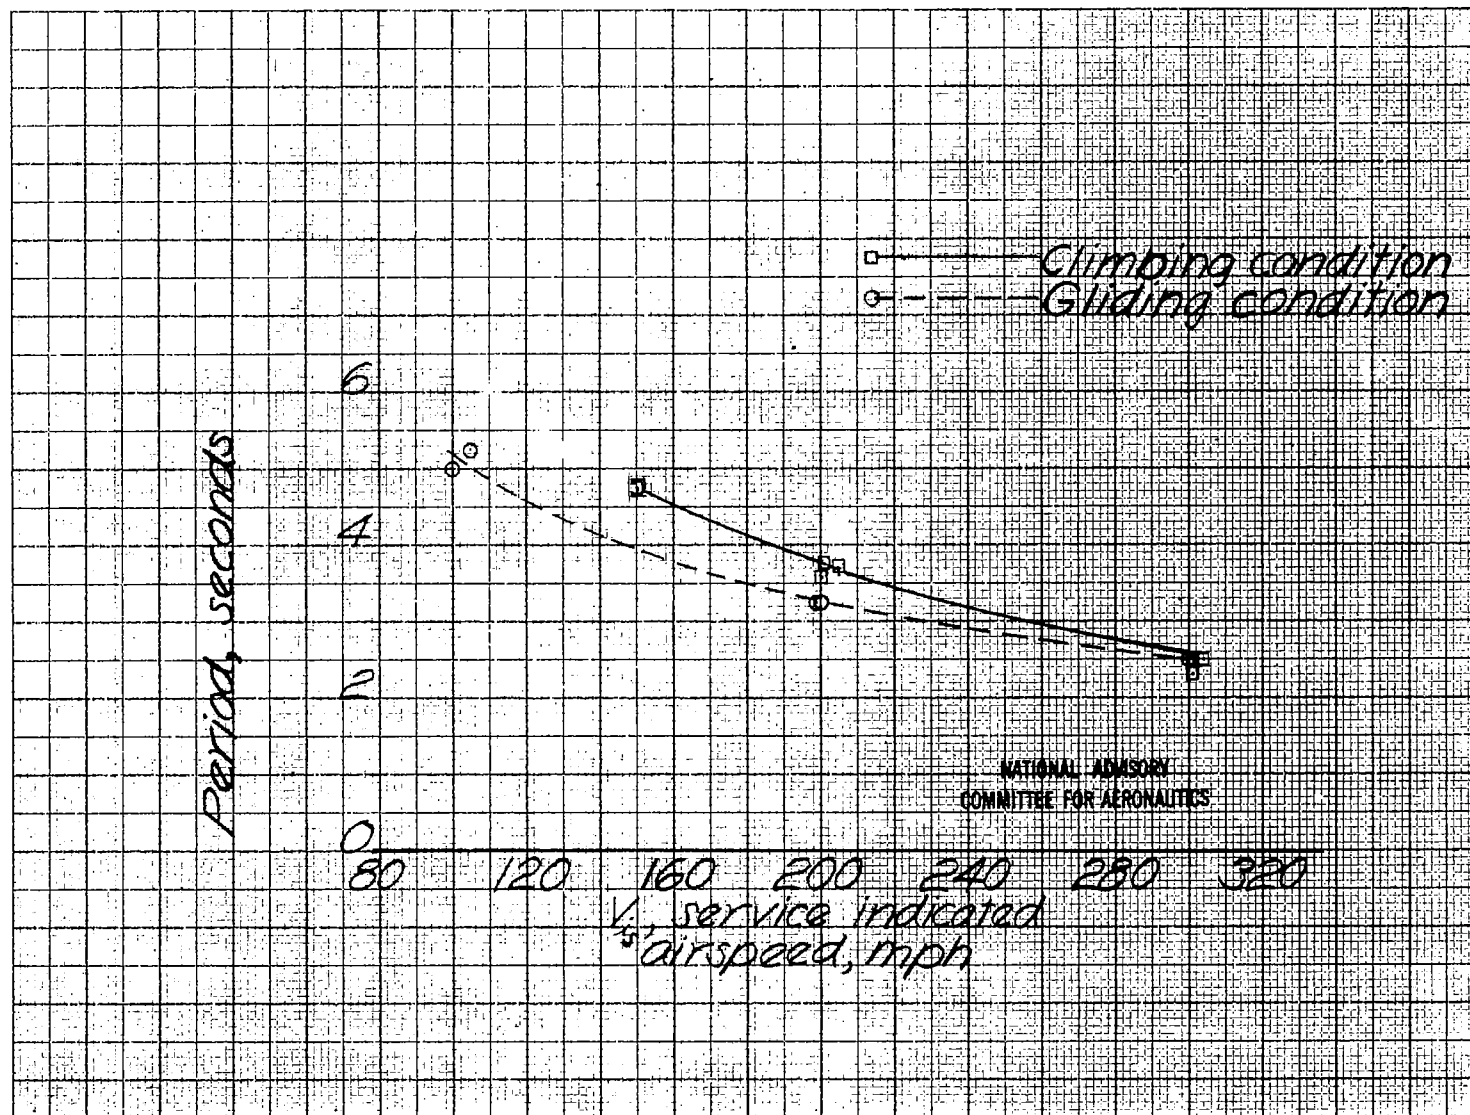
Figure 7. - Variation of the period of lateral oscillations with service indicated airspeed, F6F-3 airplane.

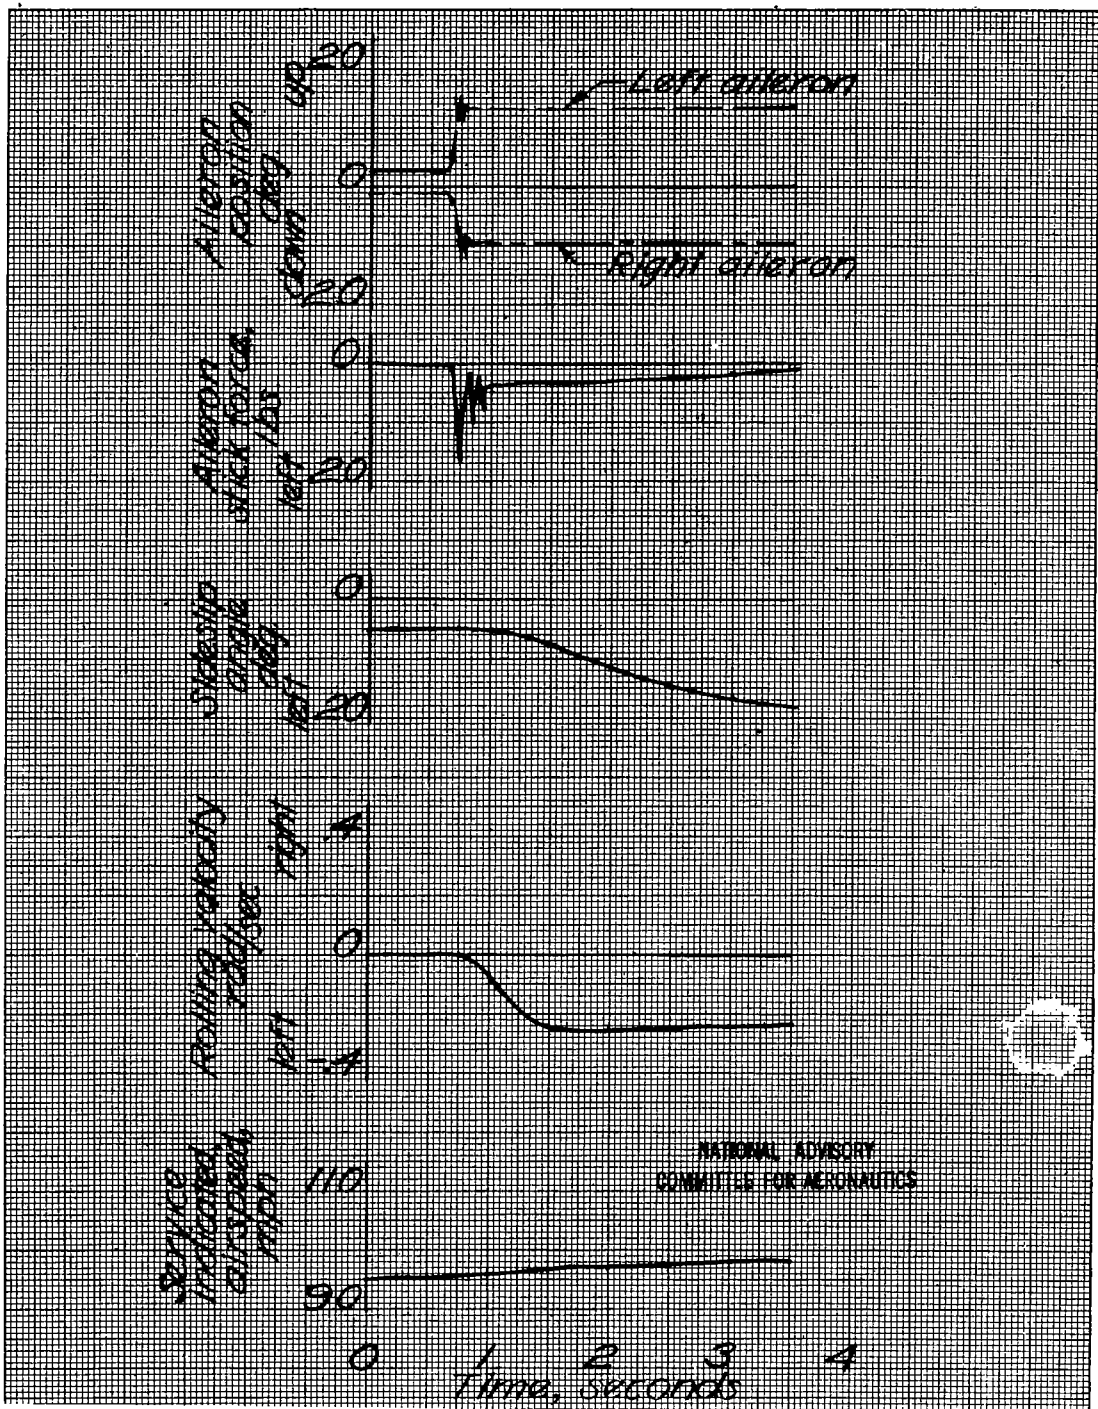
Figure 8. - Typical time history of an abrupt aileron roll made at approximately 95 miles per hour using partial aileron deflection, rudder fixed, clean condition, power for level flight, F6F-3 airplane.

Figures 8 and 9 give time histories of typical aileron rolls made from laterally level flight. It should be noted that where the use of full aileron deflection is indicated, as in figure 9, the aileron stick force shown is not a true measure of the force required to deflect the ailerons as the stick is against the stops. The data obtained from the aileron rolls were evaluated to determine the variation of aileron effectiveness $pb/2V$ and change in aileron stick force with change in total aileron angle. These data are presented on figure 10. From these data, it was possible to determine the helix angle, $pb/2V$, and

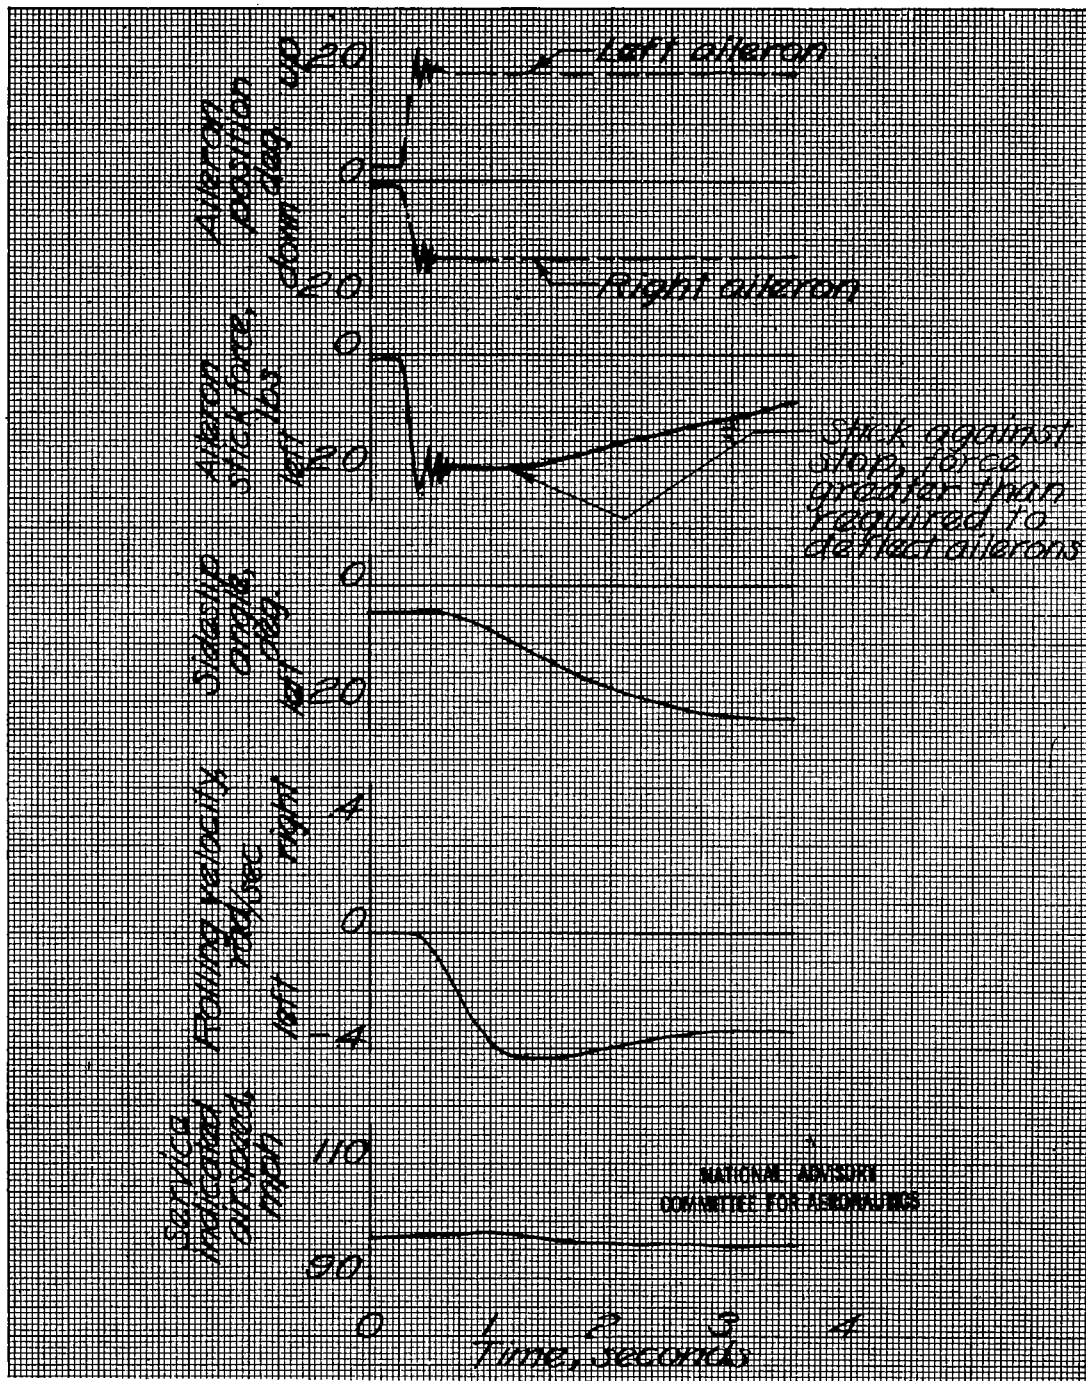
Figure 9. - Typical time history of an abrupt aileron roll made at approximately 97 miles per hour, using full aileron deflection. Clean condition, power for level flight, F6F-3 airplane.

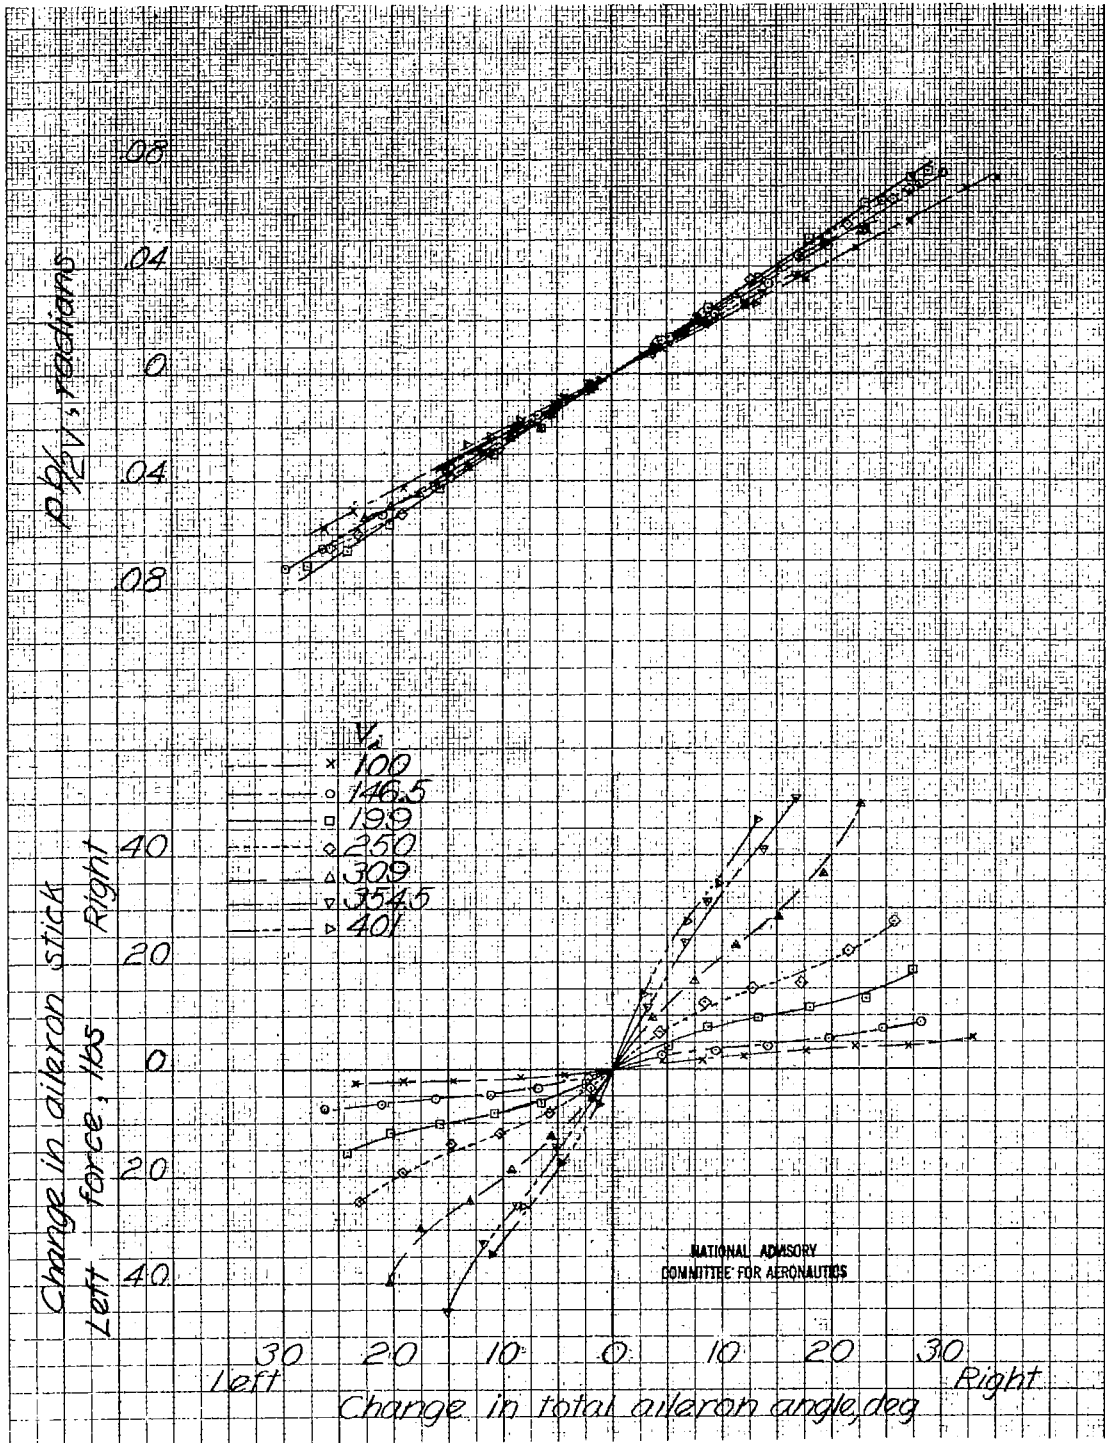
Figure 10. - Variation of the helix angle $pb/2V$ and change in aileron stick force with change in total aileron angle at various speeds, F6F-3 airplane.

rolling velocity obtainable with any stick force through the speed range of the tests. Figure 11 gives the values of $pb/2V$ obtainable with a 30-pound stick force as a function of speed. The Navy and NACA requirements of values of $pb/2V$ of 0.08 and 0.07, respectively, up to 80 percent of the maximum level-flight indicated airspeed (reference 2 and 3) are also shown on this figure. Figure 12 shows the rolling velocity obtained at 10,000 feet altitude with a 30-pound stick force through the speed range. The Navy requirement of a rolling velocity of 30° per second at 400 miles per hour indicated airspeed is shown on this figure.

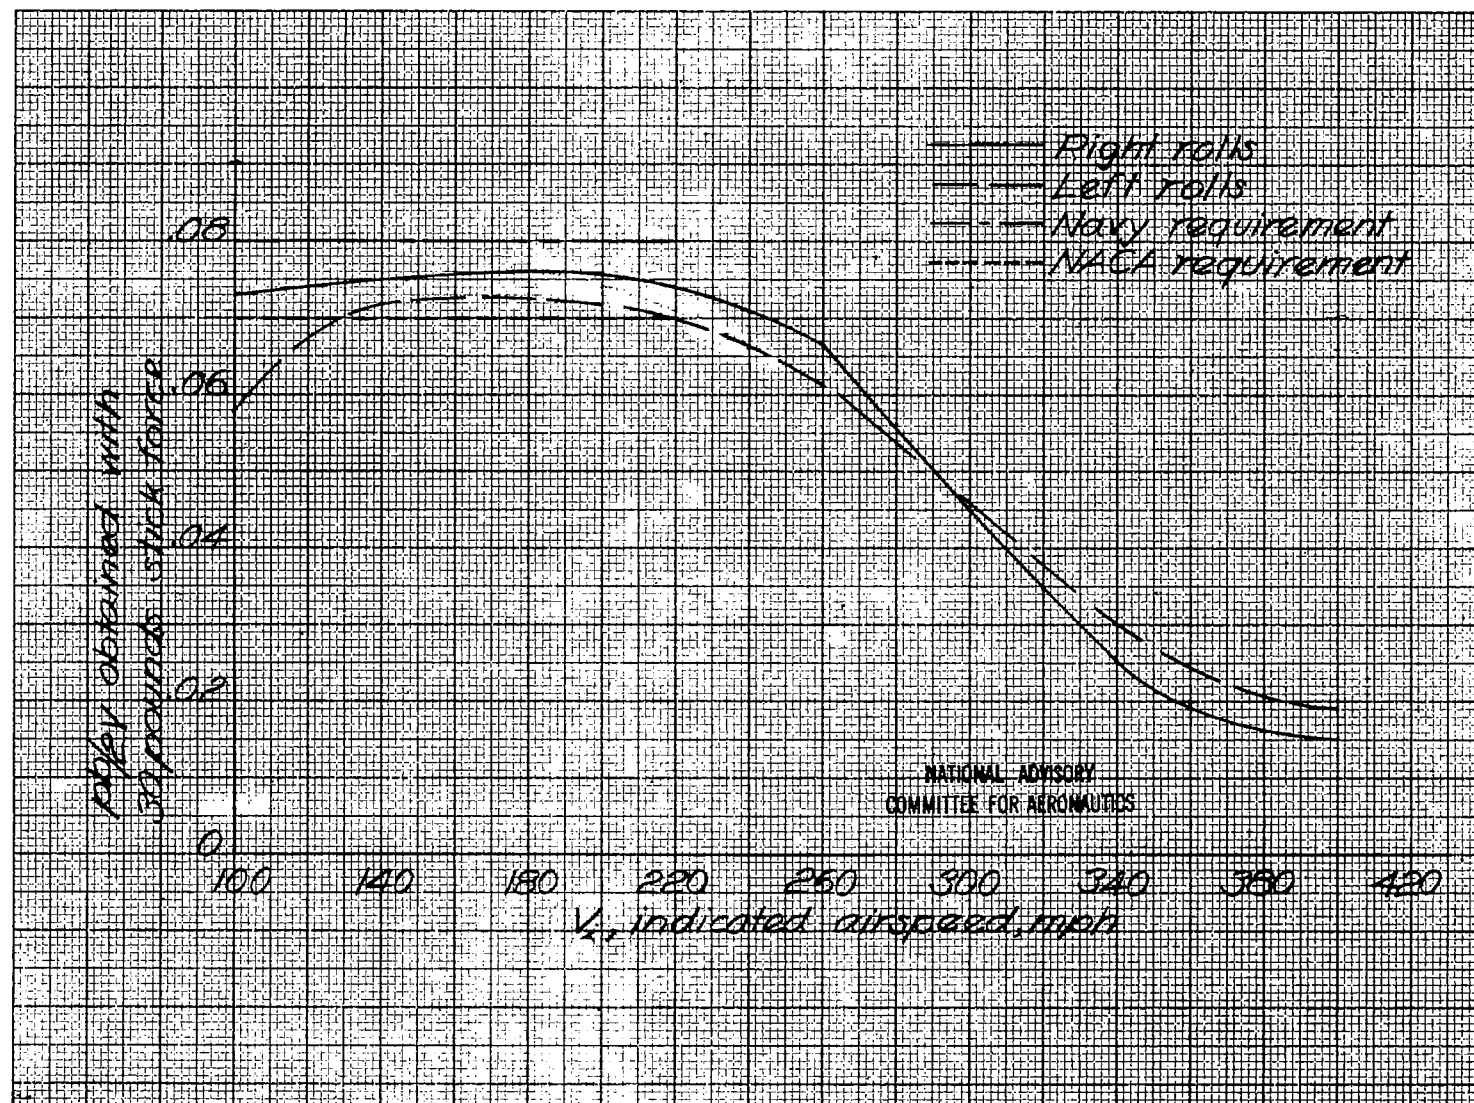
Figure 11. - Variation with indicated airspeed of the pb/2V obtained with a 30-pound stick-force limit F6F-3 airplane.

5. The F6F-3 ailerons met the NACA minimum requirement of a value of $pb/2V$ of 0.07 up to

.80 percent of the maximum level-flight speed except in rolls to the left below 130 miles per hour. (See fig. 11.)

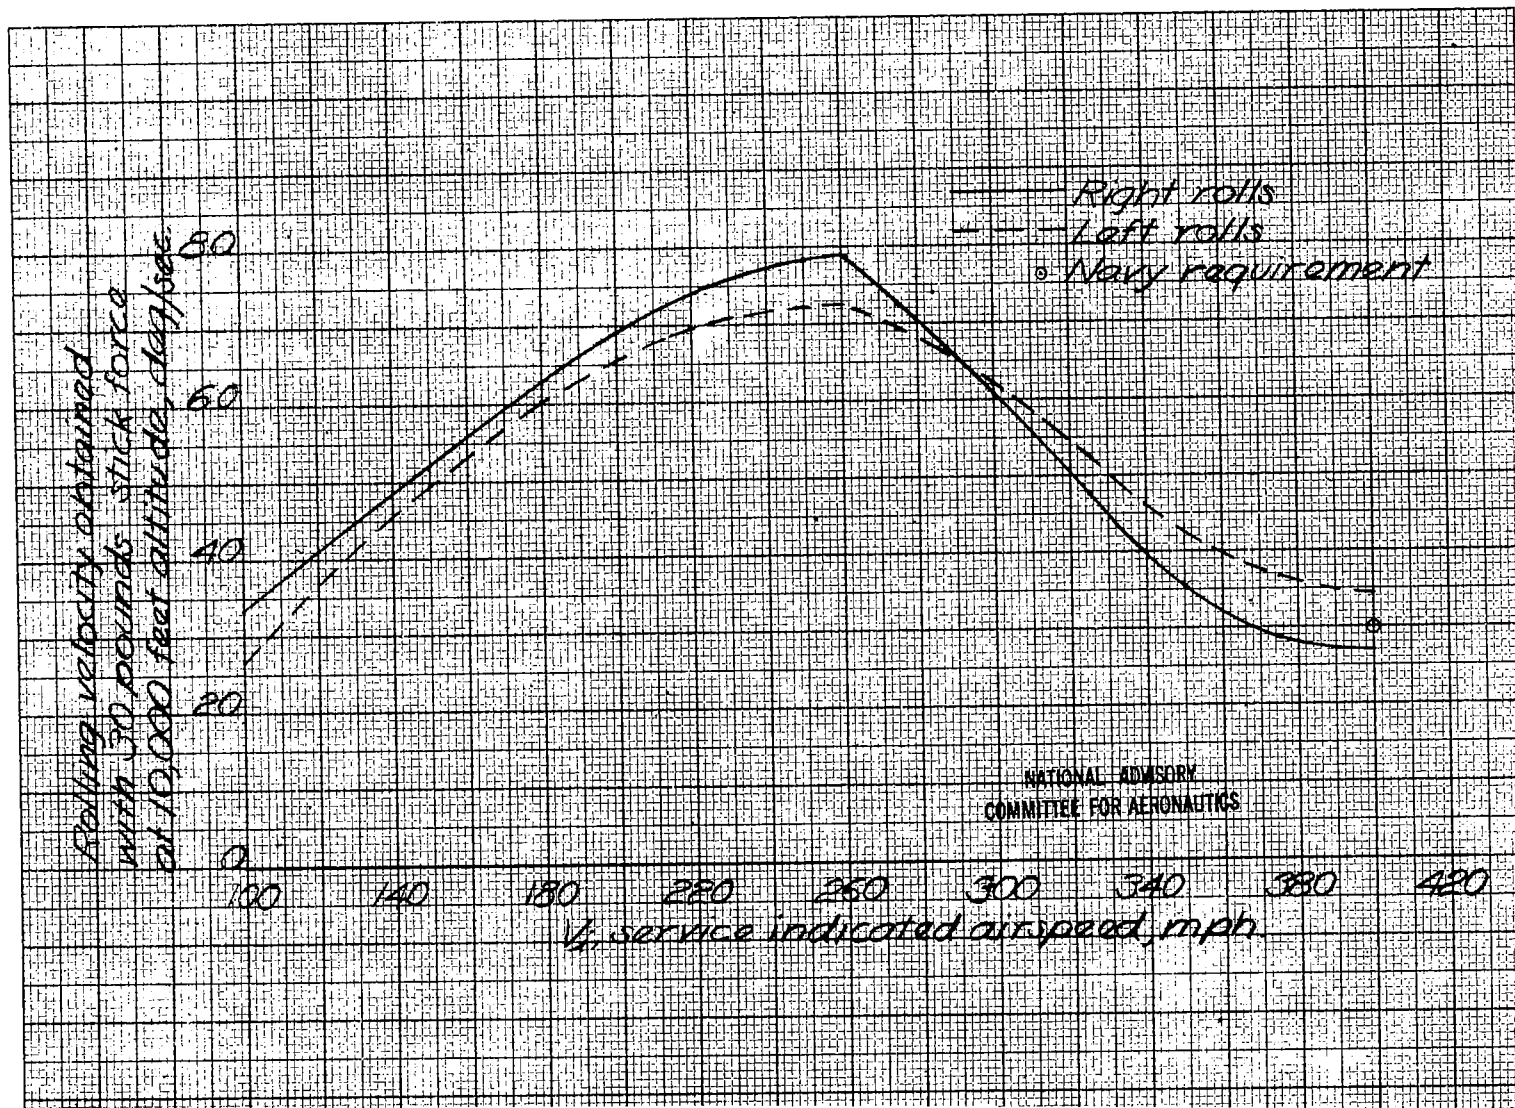
Figure 12. - Variation with indicated airspeed of the rolling velocity obtained at 10,000 feet altitude with a 30-pound stick-force limit, F6F-3 airplane.

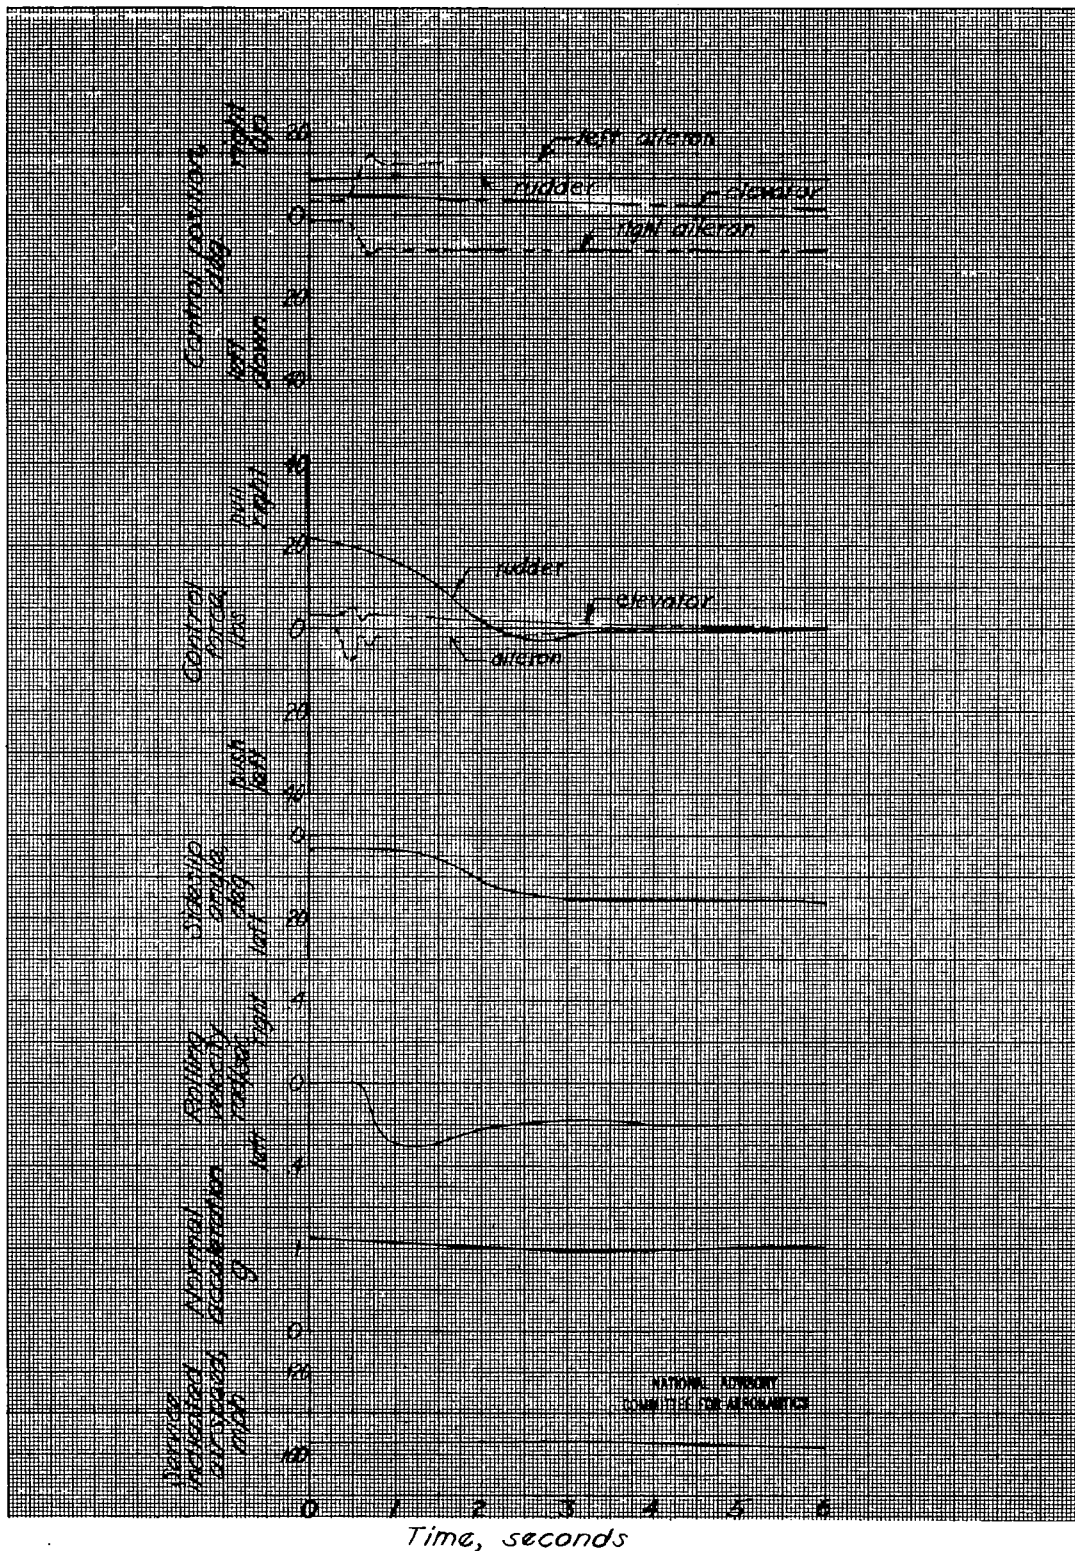
Figure 13.- Time history of rolling out of a right turn using partial aileron deflection with rudder held fixed. Clean condition, power for level flight, F6F-3 airplane.

The sideslip due to ailerons was measured in the abrupt aileron rolls from laterally level flight described above and in abrupt rolls out of turns with the rudder held fixed. The latter maneuver has been adopted as standard practice at Langley for measuring sideslip due to ailerons because it has been found difficult to obtain maximum sideslip angle in a roll from laterally level flight, since the airplane usually reaches an extreme angle of bank before maximum sideslip angle is reached. In the present instance, it was possible to reach maximum sideslip angle in right rolls from laterally level flight. Figures 8 and 9 illustrate rolls from laterally level flight. Rolls out of turns are shown in figures 13, 14, and 15. Figure 16 shows the change in maximum sideslip angle as a function of change in total aileron angle in abrupt rolls made from laterally level flight at 98 miles per hour. Inspection of these figures shows that the use of full aileron deflection at approximately 100 miles per hour will result in approximately 18.5° of sideslip

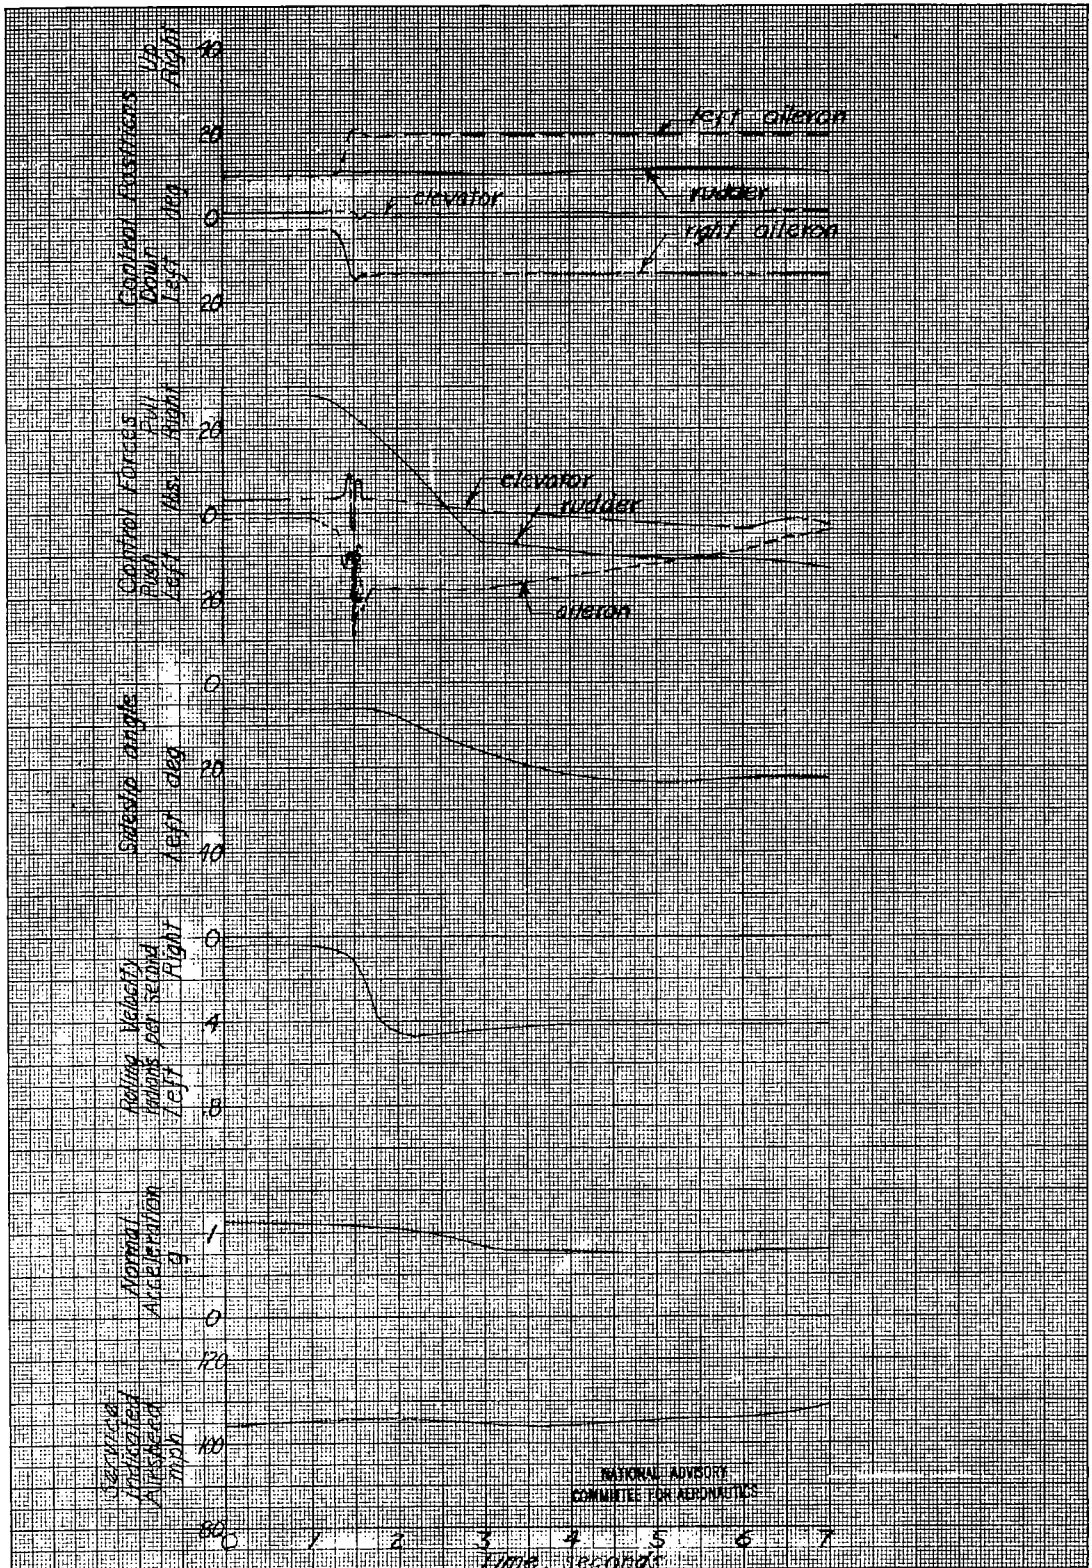
Figure 14. - Time history of rolling out of a right turn using full aileron deflection with rudder held fixed. Clean condition, power for level flight, FoF-3 airplane.
